NEW MEXICO
ENVIRONMENT DEPARTMENT
Ground Water Quality Bureau

Memorandum

Subject: Pre-CERCLIS Screening Assessment of the Section 24 Mine, New Mexico: No
Further Action Under CERLCA Recommended

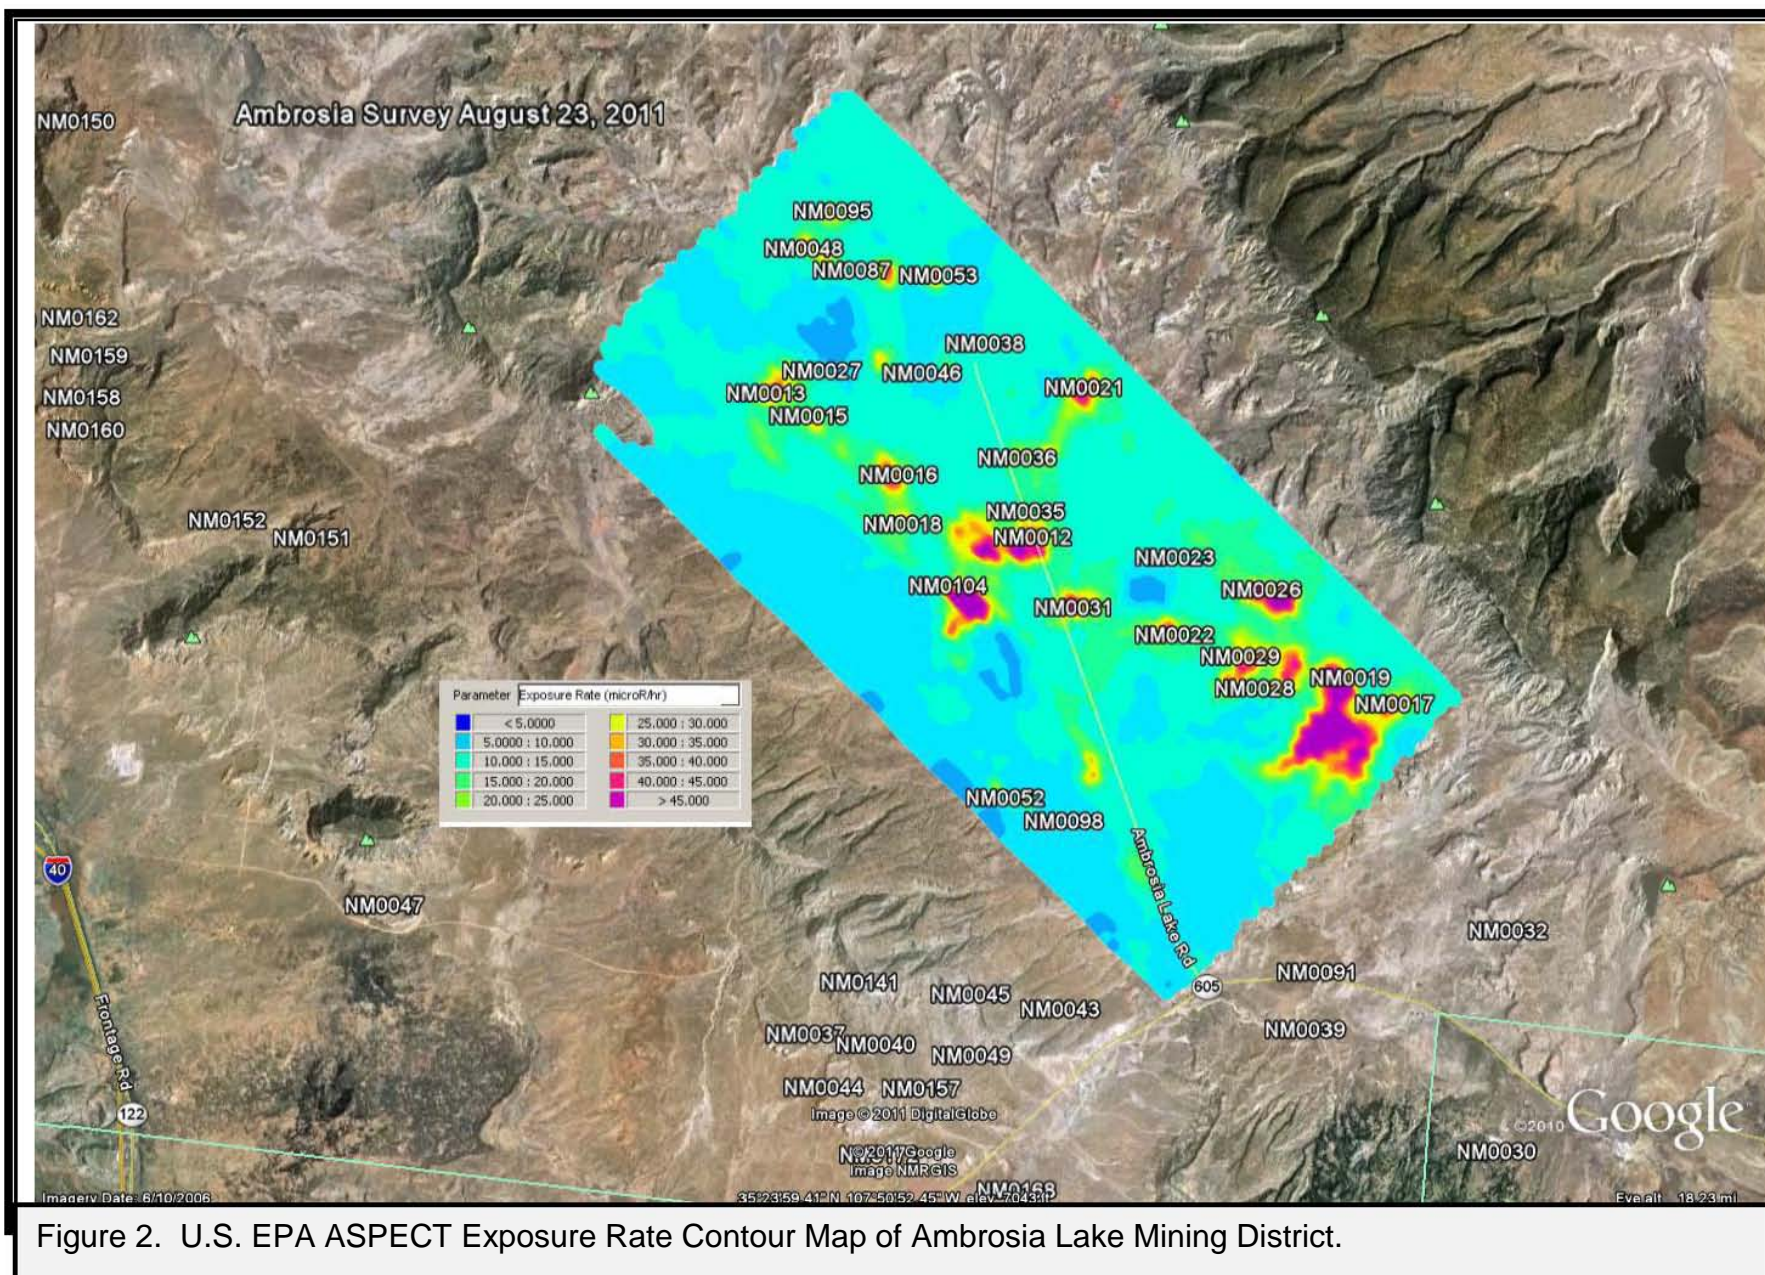
Figure 2. U.S. EPA ASPECT Exposure Rate Contour Map of Ambrosia Lake Mining District.

Airborne Spectral Photometric Environmental Collection Technology (ASPECT) operated by EPA has developed exposure rate contour map of the Ambrosia Lake Mining Sub-District that includes the Section 24 (NM0016) mine (Figure 2). The EPA ASPECT exposure rate measurements were performed in part to evaluate if surface reclamation has been effective in the long-term elimination of such threats to human health and the environment. The map estimates radiation exposure rates on the ground and can be used to identify hazardous levels of radiation. Typical exposure rates in New Mexico range from 5 – 20 micro Roentgens per hour ($\mu\text{R/hr.}$). The ground surface exposure rates in and around the Section 24 mine are over one thousand times higher than the typical range, that is, ground surface radiological hazards were identified at most Ambrosia Lake uranium mine sites including the Section 24 mine (Ref. 6).
